***Replacing a Troublesome Screw Feeder with
A Geomate™ Loss-in-Weight Feeder
Extremely Low Feed Rates***

Manufacturer – 3Sigma

Case History # 114

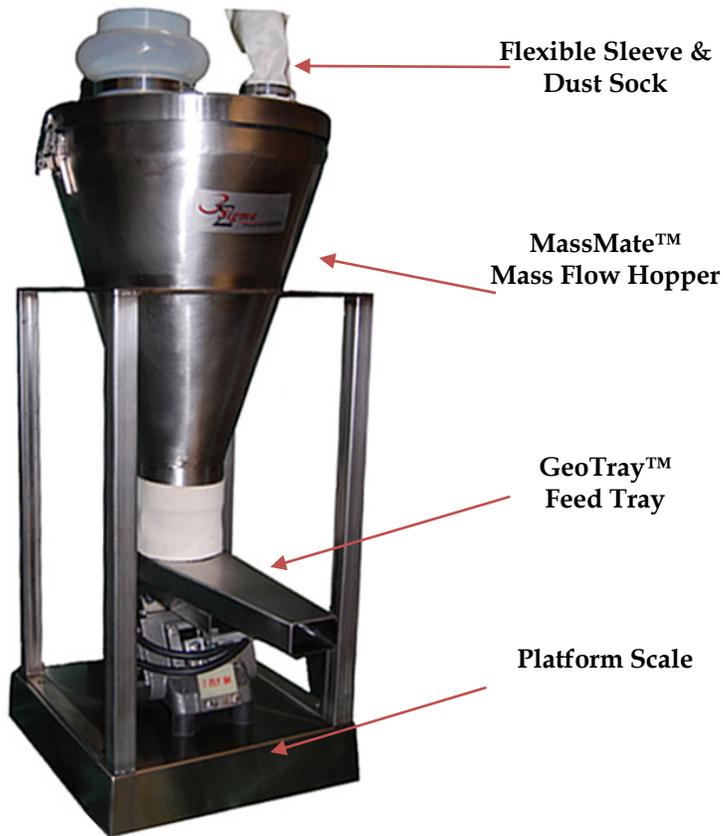
- A Geomate™ loss-in-weight system which consisted of a 4” GeoTray™, a platform scale and a LIW control system.
- The Geomate™ feeder is a mass flow system that operates with *no moving parts*.

Loss-in-Weight Control w/ Manual Control

GeoMate™ Loss-in-Weight Dry Material Feeder
