**PUBLISHED
ARTICLE**

As seen in Plant Services, November 1986

SPECIAL REPORT ON MATERIAL HANDLING

Elbow Cuts Maintenance

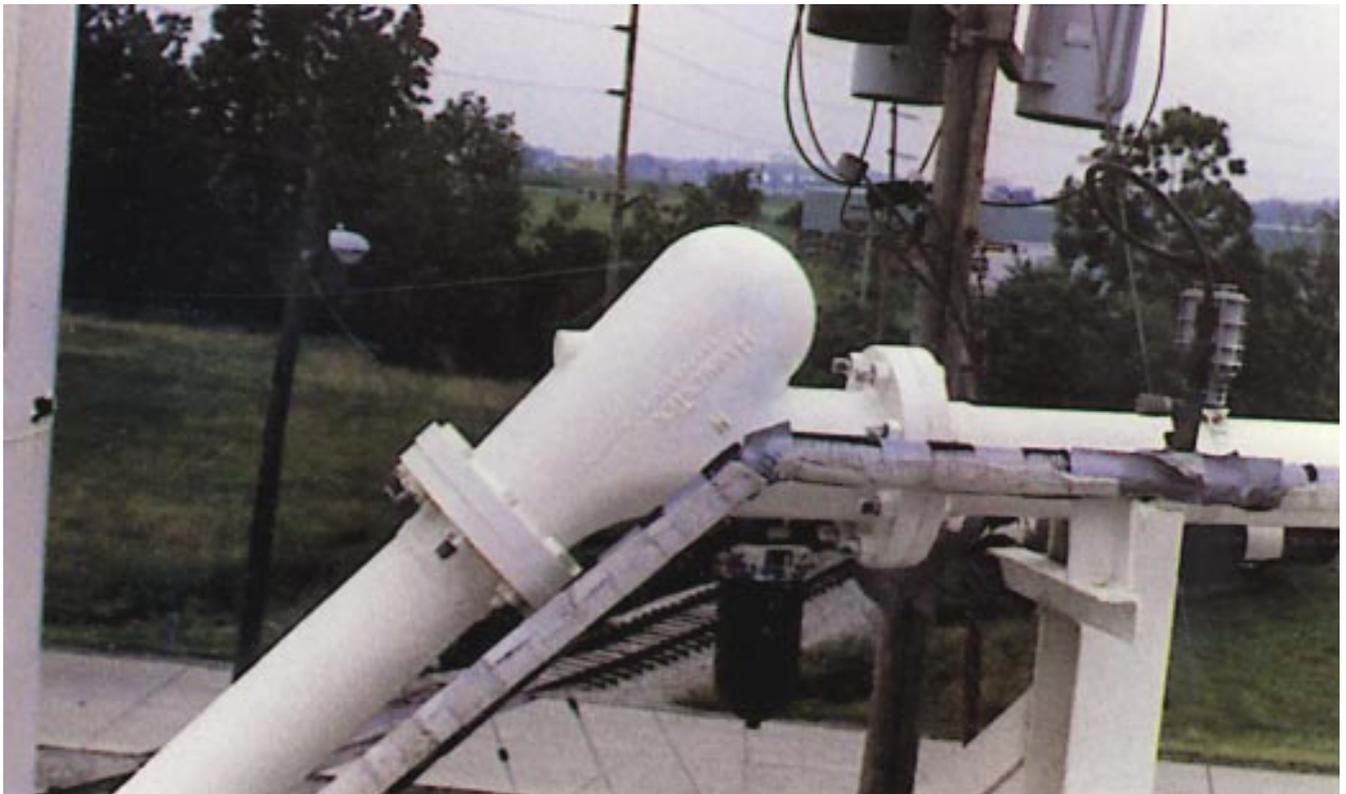
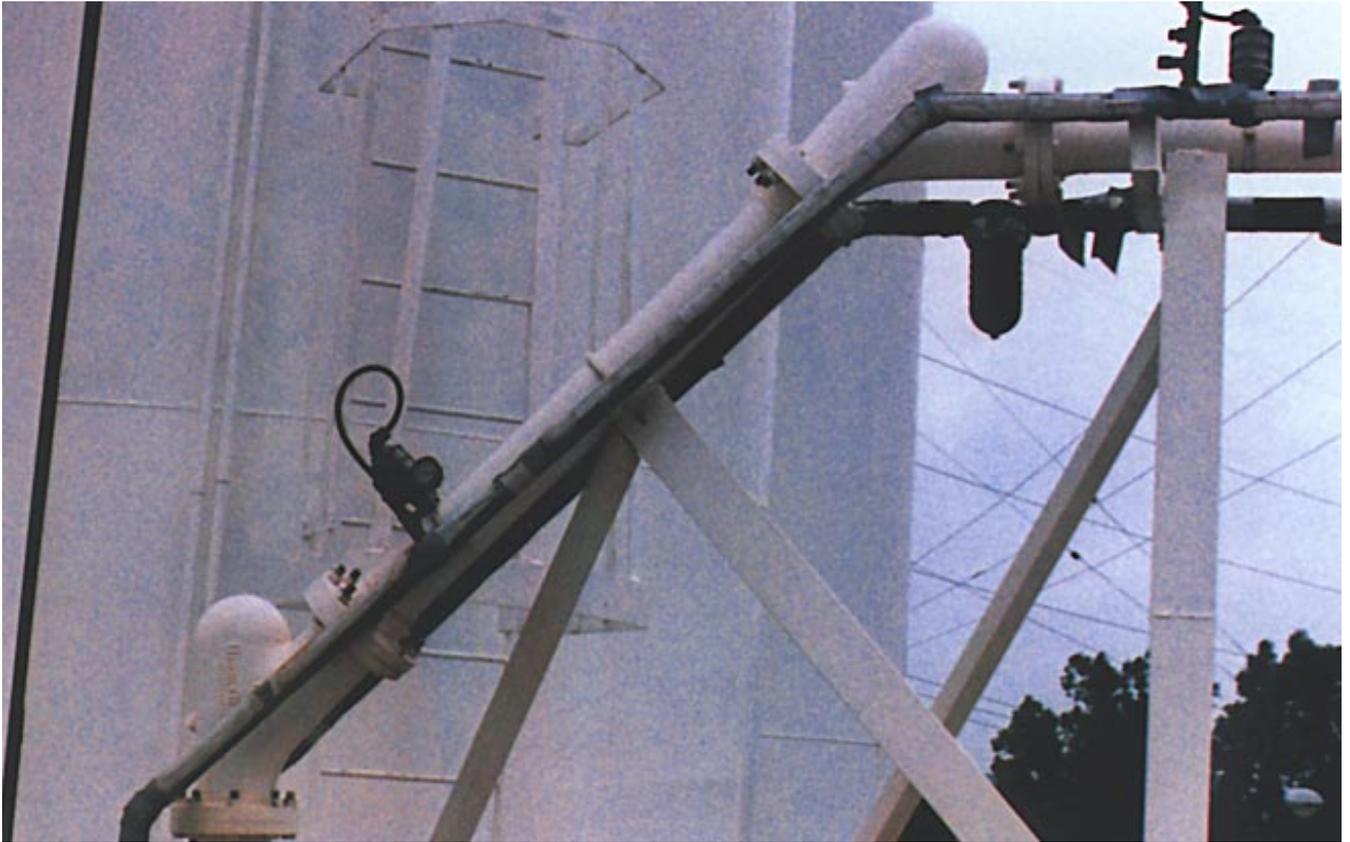
The elbow has a spherical chamber that works on an entirely different principle than most pneumatic elbows.

Some of the conveyed particles form a slowly rotating ball in the chamber. Other particles of the moving material are deflected by the material suspended in the air and given off by this soft, rotating ball. Instead of worn walls, the moving material and the air take all the abuse.

The material in the chamber is undamaged. This spherical mass of material is slightly off-center, so that the soft ball rotates—absorbing new material at

the top and losing material at the bottom. The ball is self-renewing and the gentle deflection of the conveyed material is constant.

With the spherical chamber elbow, the soft rotating ball deflects the silica aggregate and eliminates the abrasive action.
